Site Inspection, Star Stone Quarries, Inc. Santa Barbara Mine, S/013/006, Duchesne

County, Utah

Purpose of Inspection: To examine the site in consideration of operator's request for release.

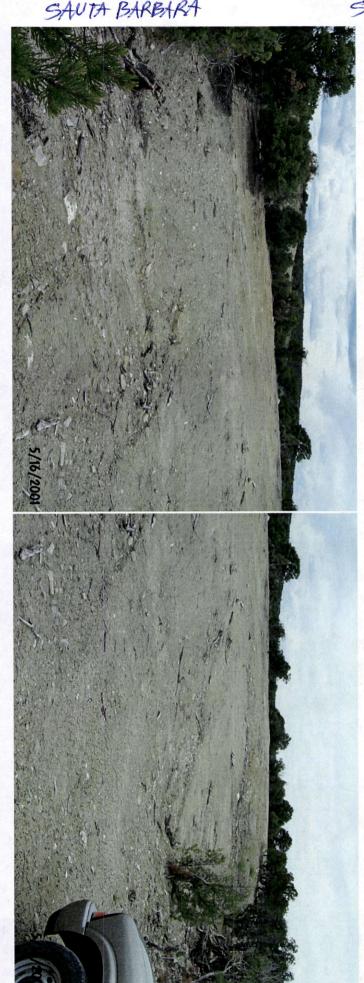
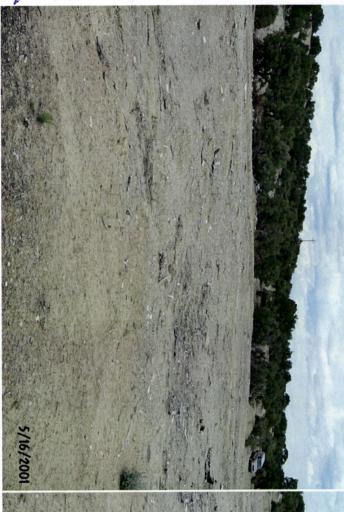
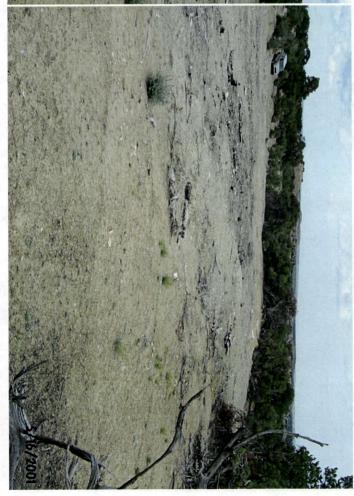
The perimeter of the site was walked beginning and ending at the east end. The quarry has been regraded and there are no signs of debris in the regraded area. The area has been regraded to a smooth surface, and there is no vegetation on the site at this time. Very little litter or debris was found around the perimeter of the main quarry site and what was found was not necessarily from the quarry activities.

Photographs were taken to document the current status of the site. The state vehicle in the photographs is parked on the eastern end facing approximately south – southwest. The regrading and cleanup of the site is complete, however, the site has not yet been successfully revegetated. A separate letter will need to be sent to the operator in response to the request for release.
